SERVICE BULLETIN

SB-050224-A

ID NUMBER & REVISION: SB-050224-A
SUBJECT: (Mandatory) Rudder Pedal Cable Chafing
RELEASE DATE: 08 July 2024
EFFECTIVE DATE: 08 July 2024
SUPERSEDES NOTICE: N/A
AIRCRAFT AFFECTED: **MAKE & MODEL:** ICON A5
SERIAL NUMBERS: 00001-00062, 00064-00083, 00085-00100, 00102-00163, 00165-00184, 00186-00190, 00192, 00194-00198, 00199, 00201, 00204, 00205

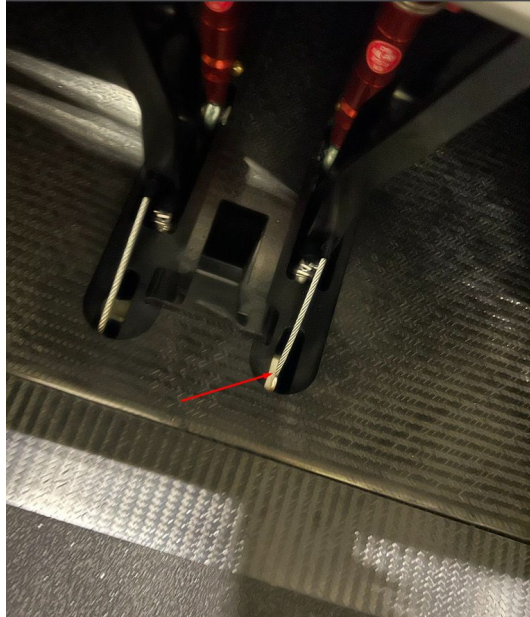
2. Permissible to remove the aft floorboard panels from the aircraft per the Maintenance Manual for improved visibility.
3. Move the rudder pedals, in their full range of motion, paying close attention to AFT Recessed Floor Closeout Panel (**Figure 2**) and Floor Closeout Retainer Bracket (**Figure 1**). The condition is most evident with the pedals in the aftmost position. Using a sharpie pen, mark any interference present on AFT Recessed Floor Closeout Panel and/or Floor Closeout Retainer Bracket. The interference will be removed in a subsequent step.

Figure 1. Rudder Pedal Cable Chafing on Retainer Bracket

3. For the floor close out retainer bracket:
 - c. Permissible to remove up to .400" from the bracket; however, material may have previously been removed. Measure the bracket to ensure that the total amount of material removed does not deviate more than .400" from what is shown in **Figure 3**.

- d. Minimally blend the affected areas to achieve a blend ratio 20:1 to allow clearance. From the edge, maintain a maximum blend depth of 0.100 inch.

- e. Re-protect the blended area using Alodine 1132 Touch-N-Prep Pen
 - i. Rinse thoroughly while wiping with a clean cloth (such as cheesecloth) until the cloth remains clean (no dark residue is picked up from the surface). All residues must be removed before proceeding.

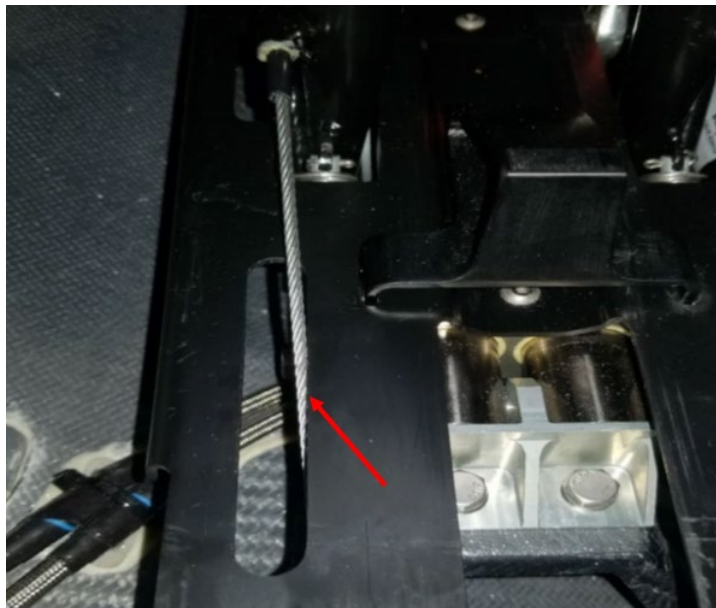
Figure 2. Relieve interference for AFT Recessed Floor Closeout Panel

1. Remove FWD Cockpit Floor Assembly.
2. For the AFT Recessed Floor Closeout Panel:
 - a. Minimally trim along the free edge of the aft floor closeout panel at the area of interference as required to permit proper fit. See **Figure 2** for reference. From the edge, maintain a maximum blend depth of 0.200 inch and length to mimic the original profile of the cutout.

- b. Dress out blend area to remove tight corners, or abrupt changes to profile of the part. Maintain minimum inside and outside edge radii of 0.5 inch. Maintain surface blend ratio of 20:1.
