SERVICE LETTER SL-072224-A

ID NUMBER & REVISION:	SL-072224-A								
SUBJECT:	Canopy Latch Leak Mitigation								
RELEASE DATE:	19 August 2024								
EFFECTIVE DATE:	19 August 2024								
SUPERSEDES NOTICE:	N/A								
AIRCRAFT AFFECTED:	MAKE & MODEL: A5								
	SERIAL NUMBERS: 00001-00224								
ACTION:	Apply sealant over the canopy latch screws to resolve and/or prevent								
	water intrusion into the cockpit.								
TIME OF COMPLIANCE:	Unspecified								
REVISION HISTORY:	A Initial Release								
LEVEL OF CERTIFICATION	[Pilot/Owner	\boxtimes	A & P				
REQUIRED (any level chec	ked [LSA Repairman – Inspection	\boxtimes	Certified Repair Station				
can perform task):		\times	LSA Repairman – Maintenance	\boxtimes	Manufacturer

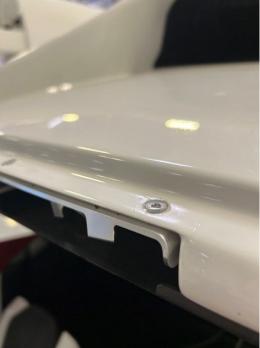
ICON has received service reports of water intrusion into the cockpit. ICON has identified that the canopy latch screws can interfere with the main canopy seal, so a solution has been developed to mitigate the potential leak path. This solution may be implemented as a preventative measure or after identification of a leak.

Figure 1. Sealant Applied Over Screw Heads

- 1. Clean region around and over canopy latch screw heads using isopropyl alcohol.
- 2. Mix and apply A-85 sealant per manufacturer's instructions to the screw head and adjacent surfaces of the Center Wing Skin. Sealant application must completely encompass the screw head and adjacent surface with no imperfections to prevent water ingress into cockpit. The sealant application should be smooth, round in shape, no larger than .50 diameter, with a .10 maximum height.
- 3. Allow 2 hours for adhesive to reach full cure.
- 4. With one person inside the cockpit, pour water (approx. 1 gallon) over the closed and locked canopy. Verify no leaks can be seen from inside the cockpit.
