SAFETY DIRECTIVE/ALERT

SD-111324-A

ID NUMBER & REVISION: SD-111324-A
SUBJECT: ELT GPS Connector Wiring (Interim)
RELEASE DATE: 10 December 2024
EFFECTIVE DATE: 10 December 2024
SUPERSEDES NOTICE: N/A
AIRCRAFT AFFECTED: **MAKE & MODEL:** ICON A5
SERIAL NUMBERS: 00201, 00209-00224
REQUIRED ACTION: Disconnect the ELT GPS Connector, then perform an ELT battery self-test prior to each flight.
TIME OF COMPLIANCE: Before next flight (1 ferry flight to service provider permitted)
REVISION HISTORY: A Initial Release

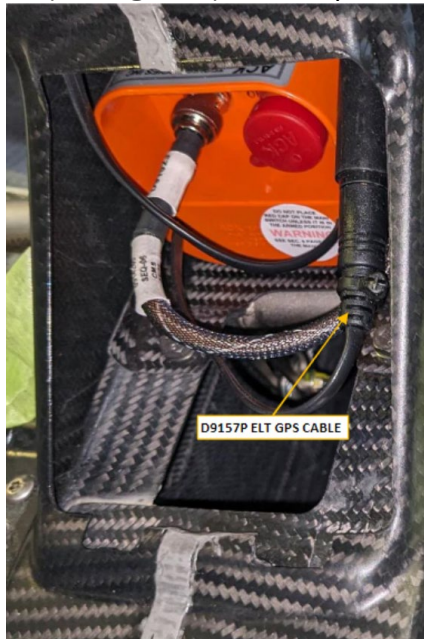
Figure 1. ELT GPS Connector D9157P

ICON has identified that the ELT GPS Connector, D9157P, may have been pinned incorrectly. This can drain the ELT battery, which may prevent the ELT from functioning. This may be recognized by a failed self-test, a red light flashing on the remote panel, and/or audible squelching from the overhead speaker.

2. Access the ELT in accordance with the Aircraft Maintenance Manual, task 100293. If desired, the Instrument Panel Top may also be removed in accordance with task 100514.
3. Disconnect the D9157P connector (ref. Figure 1) and wrap each end with F4 Tape.

4. Secure the connectors to adjacent harness as needed using TY24MX zip ties.
5. Reinstall the Instrument Panel Top (Aircraft Maintenance Manual task 100350) and/or the ELT Access Panel.
6. Complete the ELT self-test in accordance with the Aircraft Maintenance Manual, task 100139.
 - a. If the ELT battery is low, replace it in accordance with the Aircraft Maintenance Manual, task 100019.
