SERVICE BULLETIN

SB-030525-B

ID NUMBER & REVISION: SB-030525-B
SUBJECT: Repair ELT GPS Connector Wiring
RELEASE DATE: 13 March 2025
EFFECTIVE DATE: 07 March 2025
SUPERSEDES NOTICE: SD-111324-A (upon completion of this Notice); SB-030525-A
 Note: *Completion of either SB-030525-A or SB-030525-B satisfies the required action.*

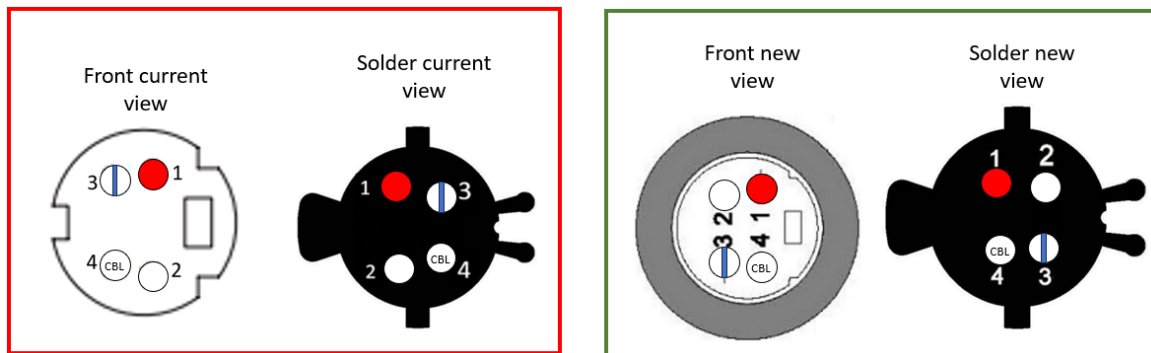
ICON has identified that the ELT GPS Connector, D9157P, may have been pinned incorrectly. This can drain the ELT battery, which may prevent the ELT from functioning. This may be recognized by a failed self-test, a red light flashing on the remote panel, and/or audible squelching from the overhead speaker.

Figure 1. Incorrect Wiring (left), Correct Wiring (right)
